WEEKLY SUMMARY REPORT

Client:	Needham DPW	Dates:	11/4/2019 to 11/8/2019
Contract:	Rosemary Lake Dredging		
Contractor:	Maverick Construction Co., Inc.	Inspector(s) on site:	Caroline Armstrong

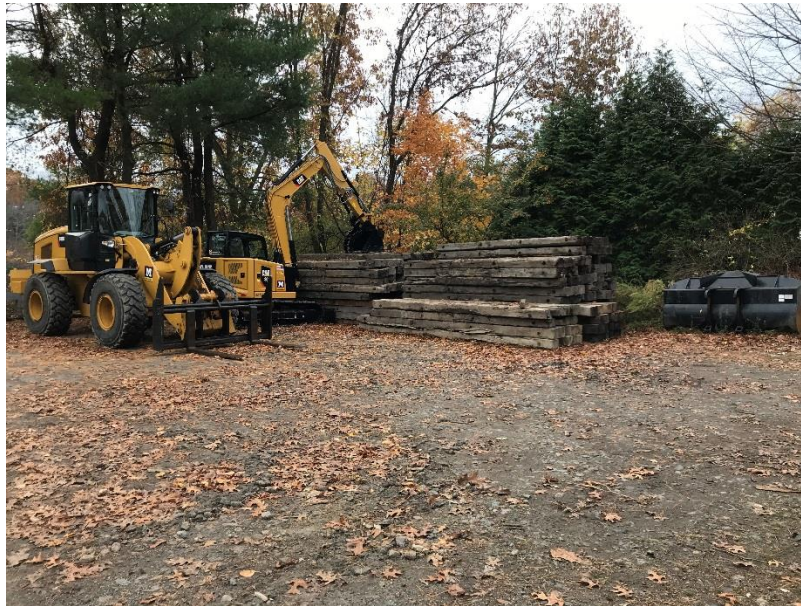
Staging Area with equipment (11/5/2019)

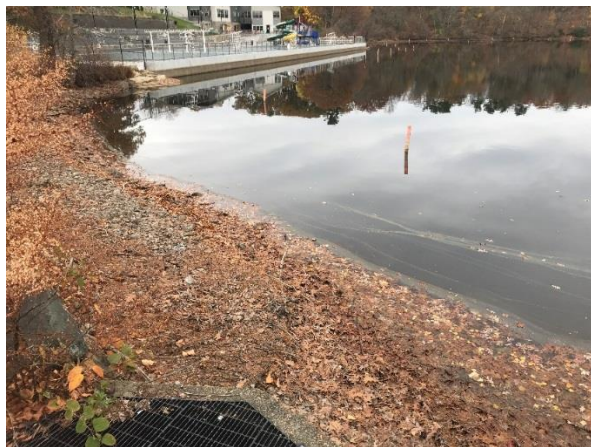
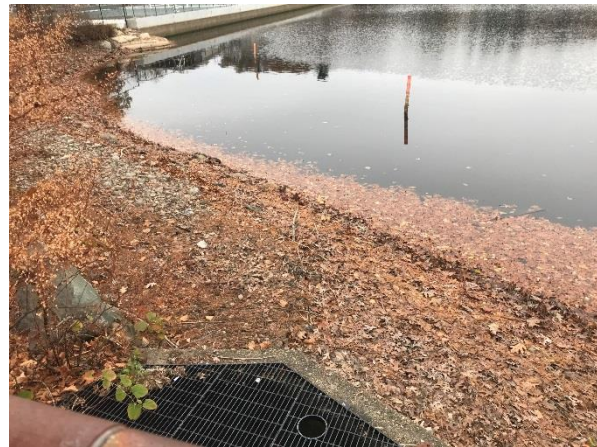
Tuesday (11/5/2019)

Lake outlet - Drawdown progress

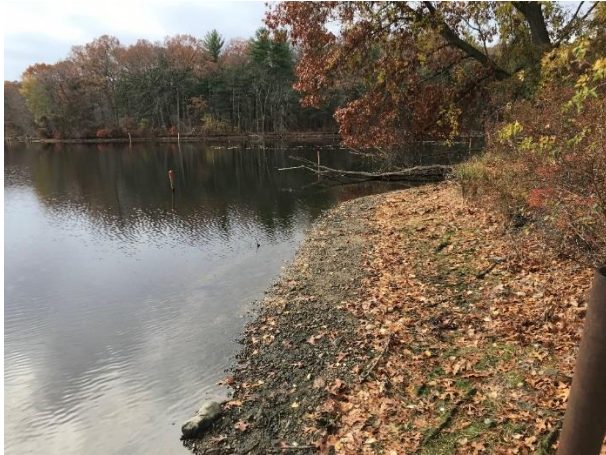
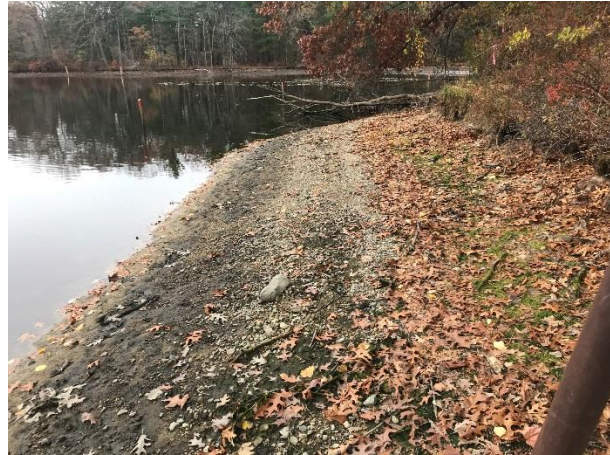
Tuesday (11/5/2019)

Lake west of Staging Area - Drawdown progress

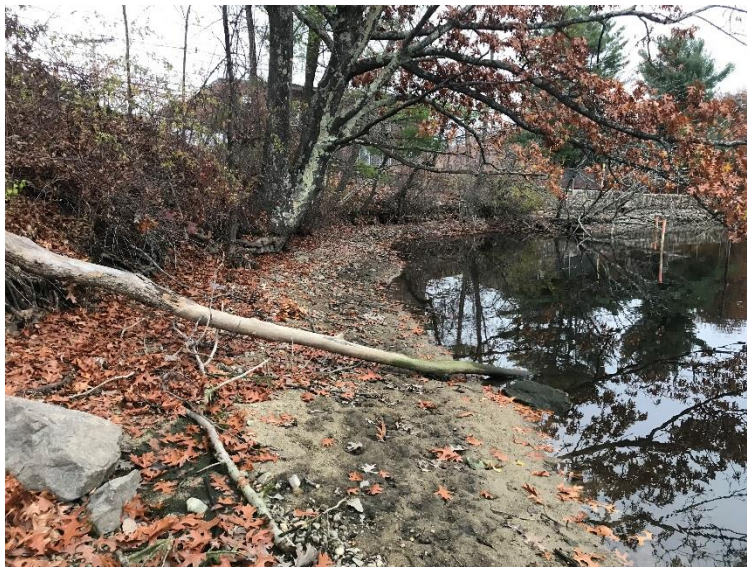
Lake east of Staging Area - Drawdown progress on Thursday (11/7/2019)

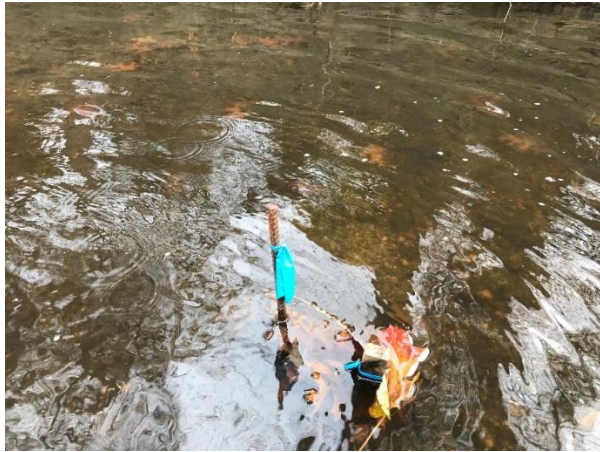
Tuesday (11/5/2019) – Water level 6" at Stake

Station 1 (Petrini Property) – Turbidity, velocity, and sediment depth readings taken. Water level 3 inches higher on Thursday than Tuesday.

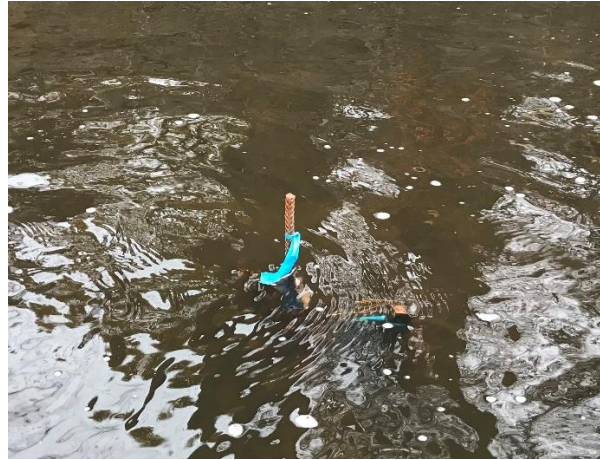
Thursday (11/7/2019) – Water level 9" at Stake

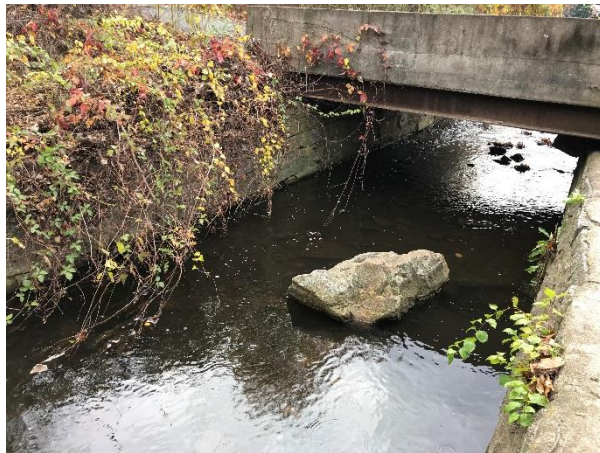
Tuesday (11/5/2019)

Station 1 (Petrini Property) – Turbidity, velocity, and sediment depth readings taken. Water level 3 inches higher on Thursday than Tuesday.

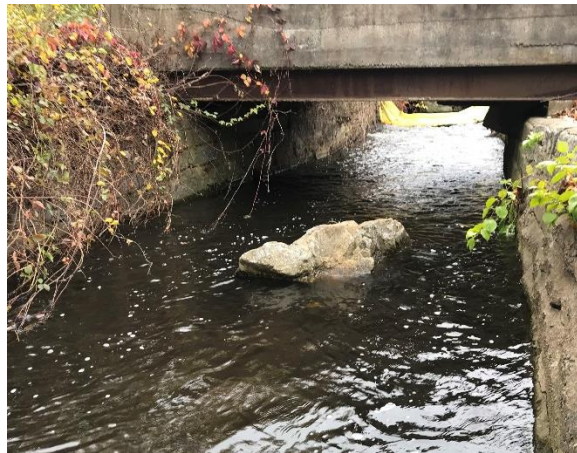
Thursday (11/7/2019) – Water level ~3" higher than Tuesday

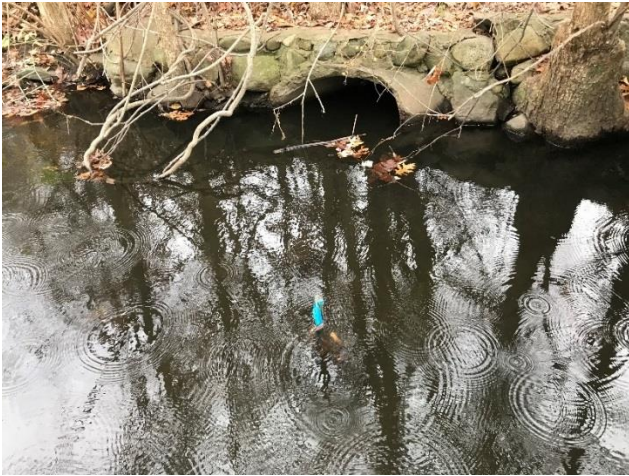
Tuesday (11/5/2019)

Station 2 (West Street) – Turbidity, velocity, and sediment depth readings taken on Tuesday and Thursday. Stake almost underwater on Thursday.

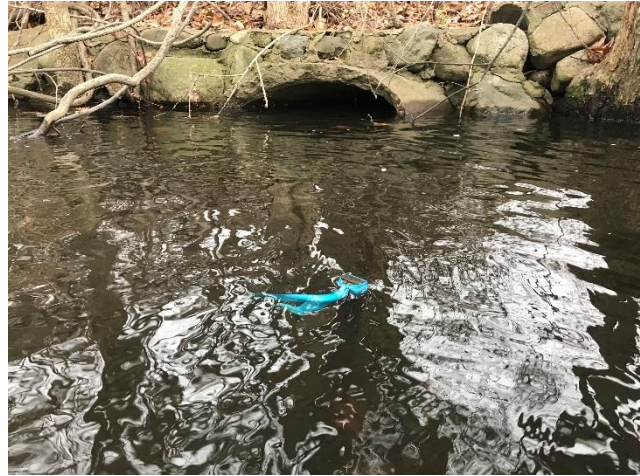
Thursday (11/7/2019) – Water level ~5" higher than Tuesday

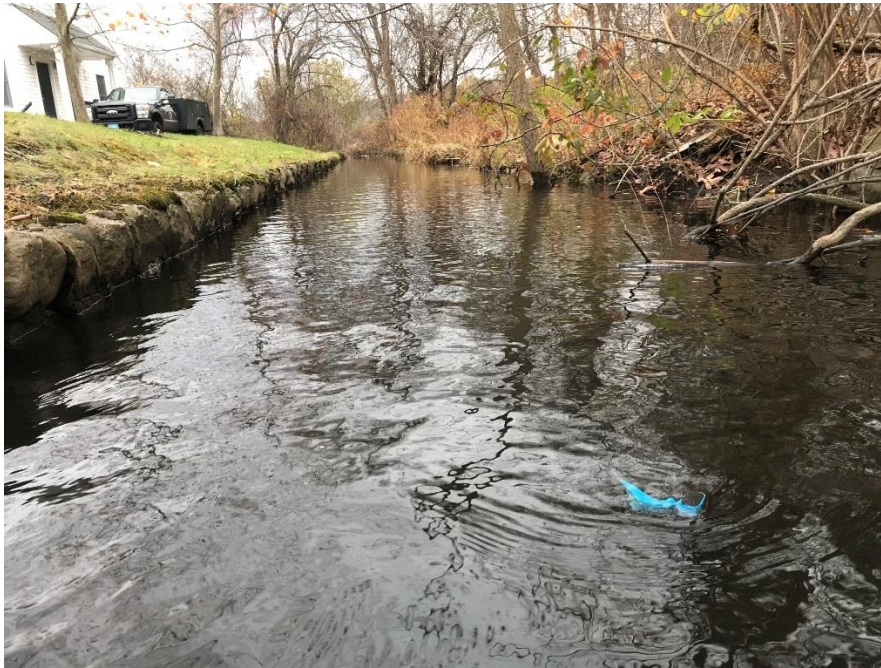
Station 2 (West Street) – View downstream of Station 2. Stake almost underwater. (11/7/2019)

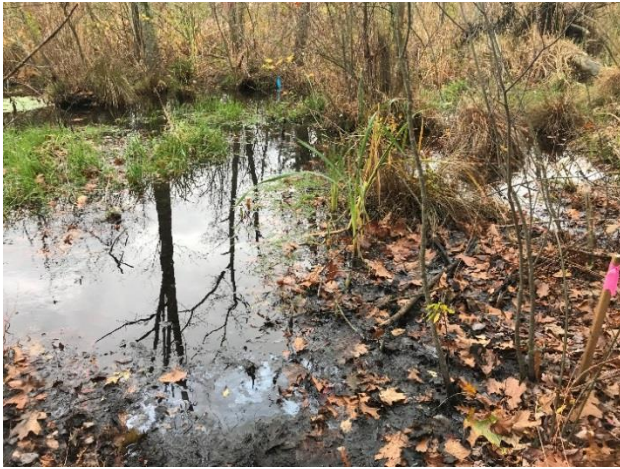
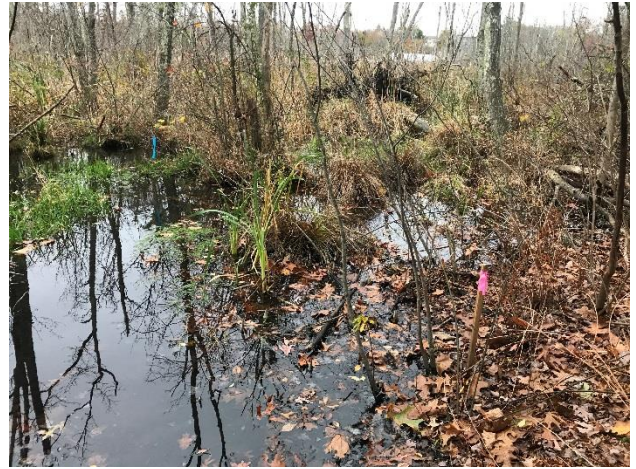
Station 5.1 (11/5/2019)

Station 5.1 – Edge of Bank shown. Turbidity, velocity, and sediment depth readings taken on Tuesday and Thursday.

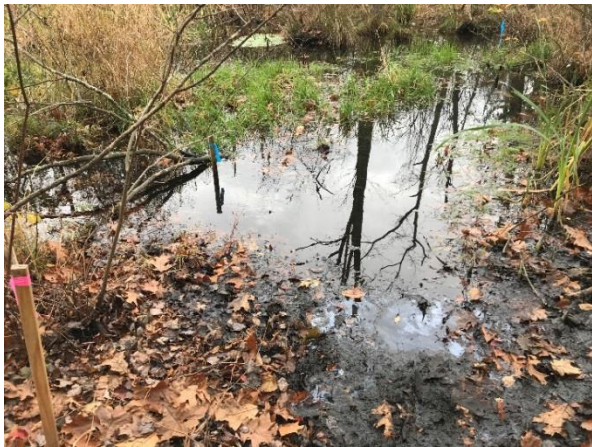
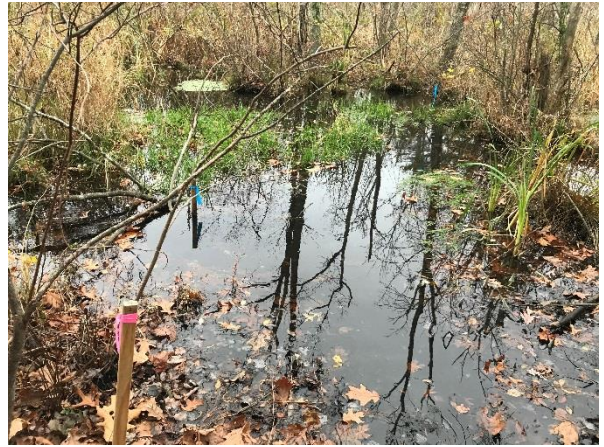
Station 5.2 (11/5/2019)

Station 5.2 – Edge of Bank shown. Turbidity, velocity, and sediment depth readings taken on Tuesday and Thursday.

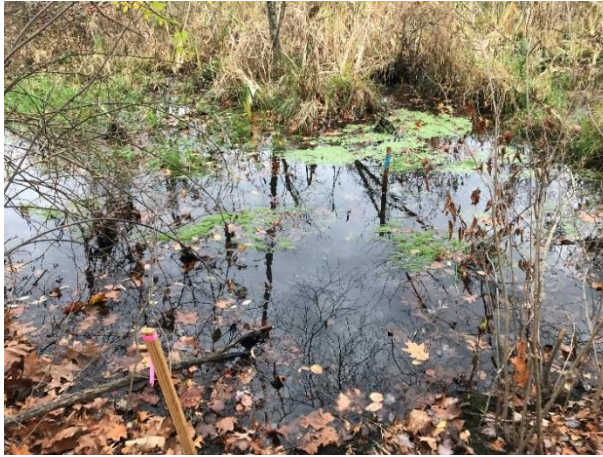
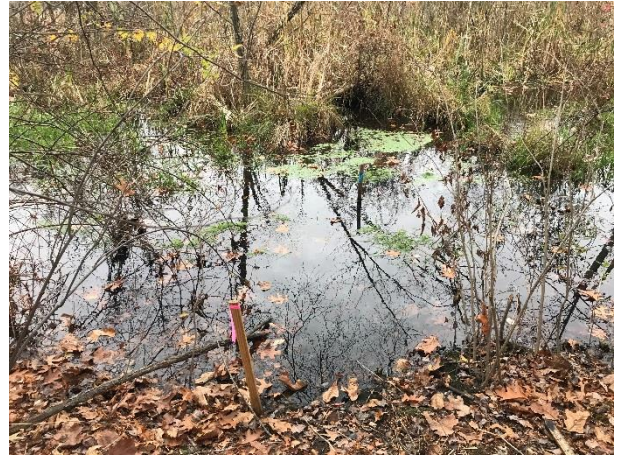
Station 5.3 (11/5/2019)

Station 5.3 (Whalen Property) – Edge of Bank shown. Turbidity, velocity, and sediment depth readings taken on Tuesday and Thursday

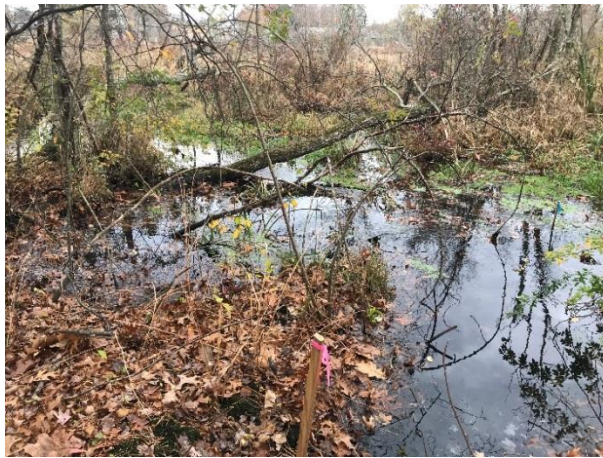
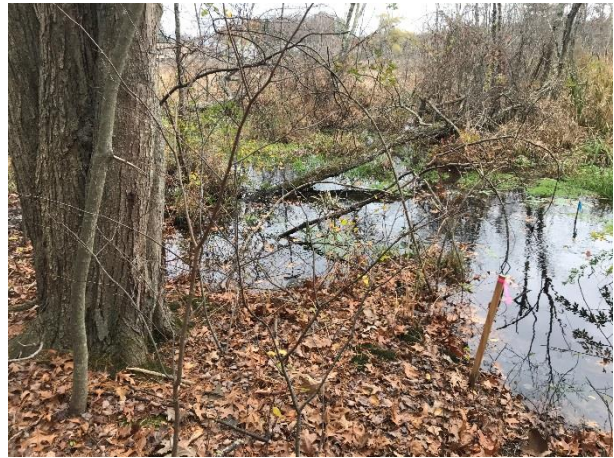
Station 5.4 (11/5/2019)

Station 5.4 (Whalen Property) – Edge of Bank shown. Turbidity, velocity, and sediment depth readings taken on Tuesday and Thursday

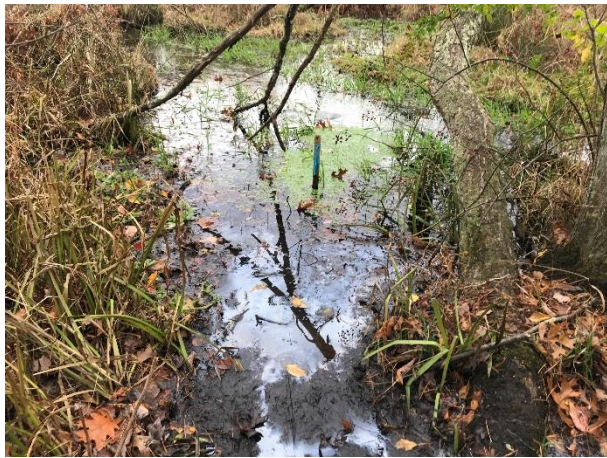
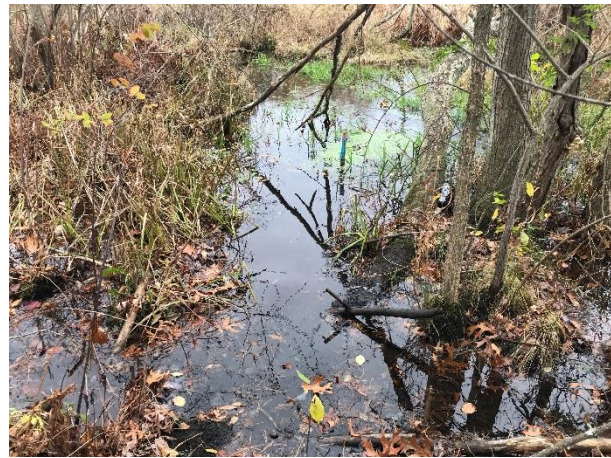
Station 5.5 (11/5/2019)

Station 5.5 (Whalen Property) – Edge of Bank shown. Turbidity, velocity, and sediment depth readings taken on Tuesday and Thursday
